Debris/Ice/TPS Assessment and Integrated Photographic Analysis of Shuttle Mission STS-79

**DEBRIS/ICE/TPS ASSESSMENT
AND
INTEGRATED PHOTOGRAPHIC ANALYSIS
OF
SHUTTLE MISSION STS-79**

16 September 1996

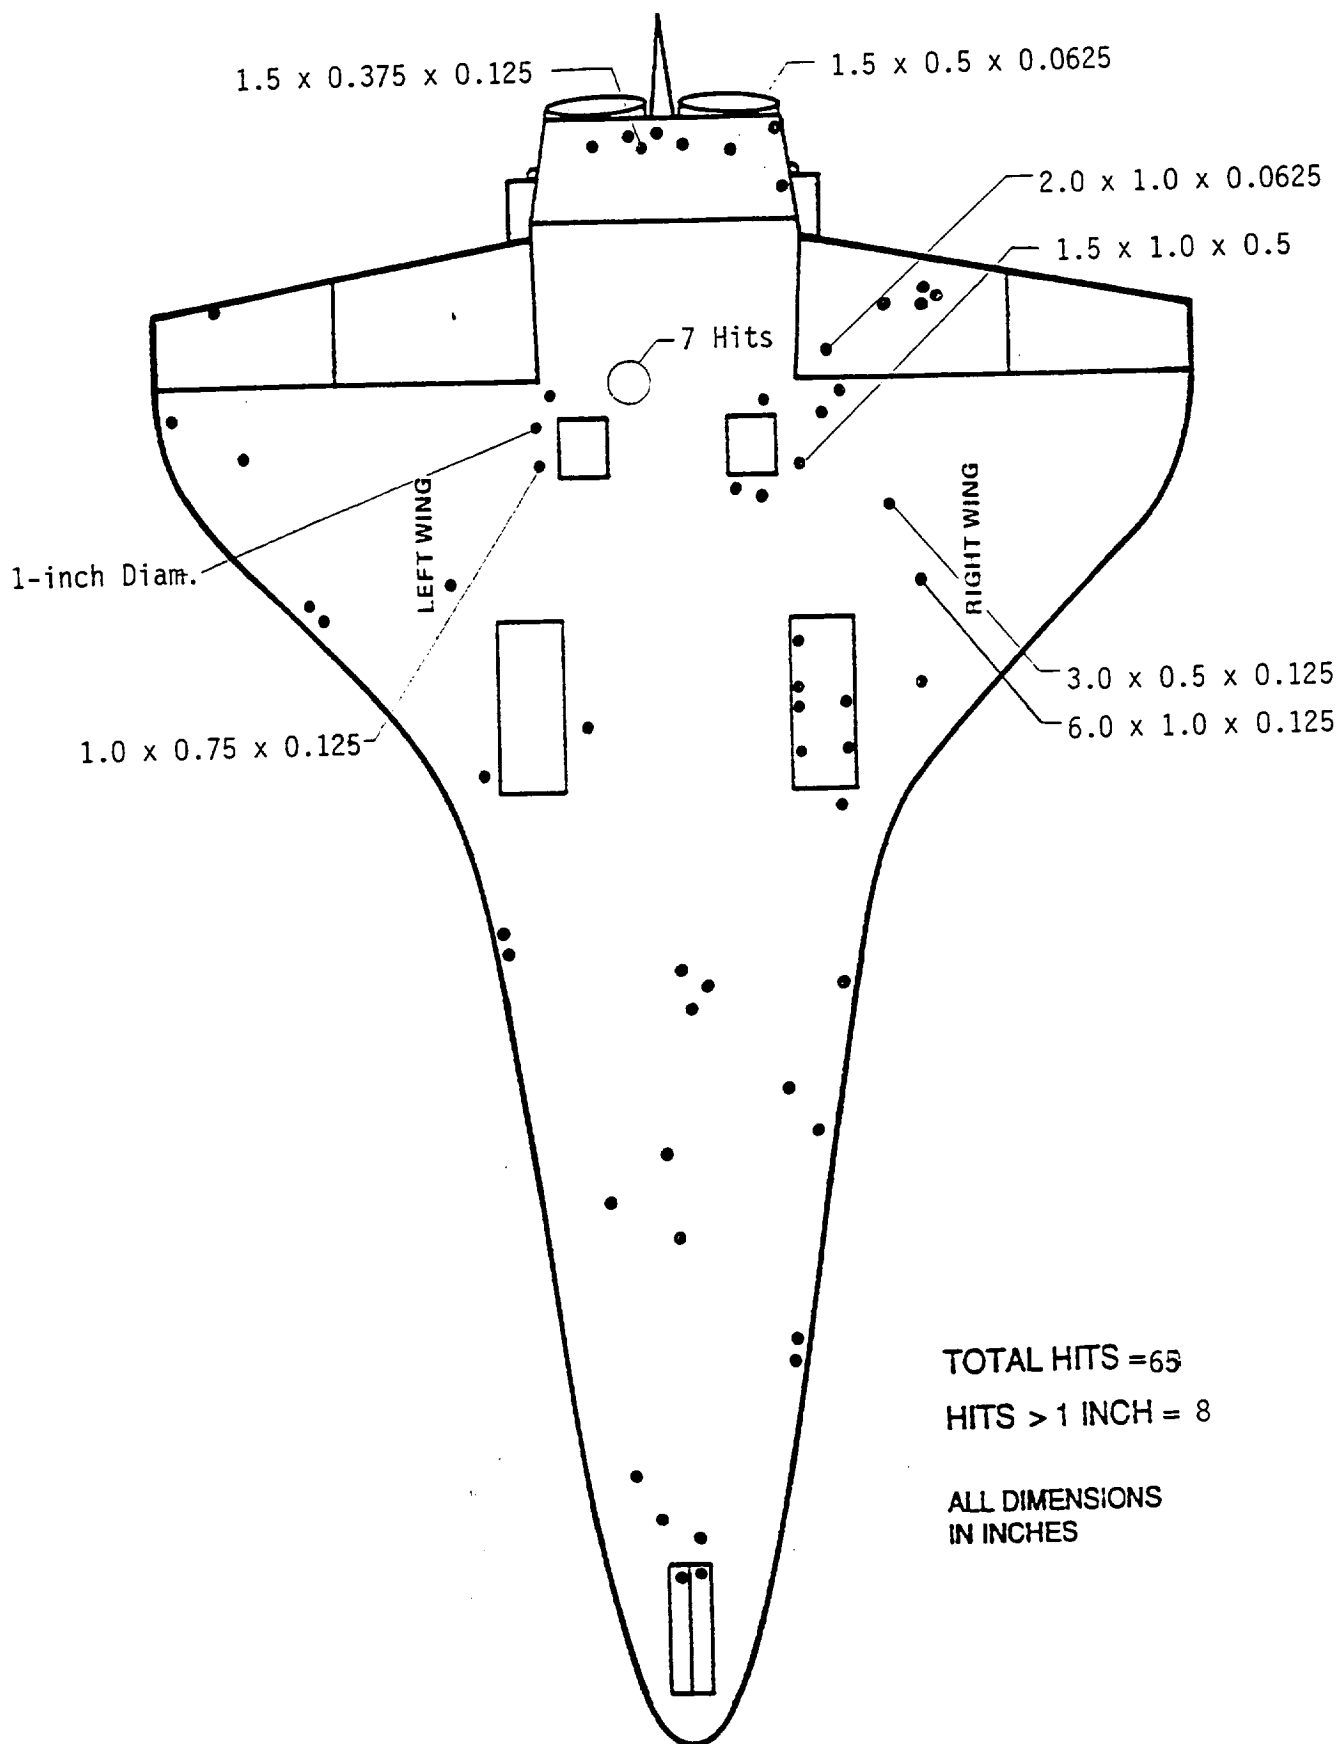
Figure 3: Orbiter Lower Surface Debris Map

The Orbiter lower surface sustained a total of 65 hits, of which 8 had a major dimension of 1-inch or larger. The largest lower surface tile damage site was located outboard and aft of the right main landing gear door and measured 6.0-inches long by 1.0-inches wide by 0.125-inch maximum depth. The damage was most likely caused by an ice impact from the ET LO2 feedline bellows and support brackets.

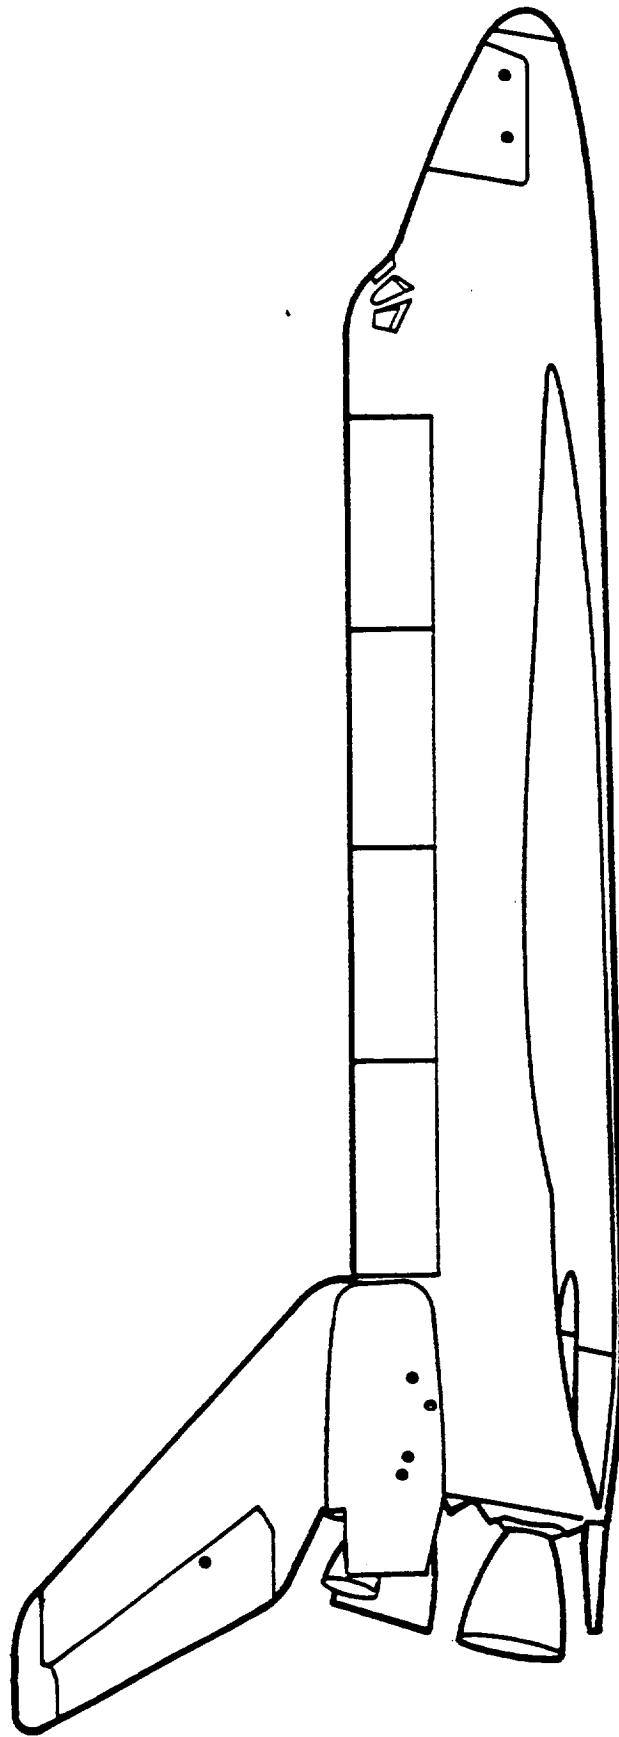
Figure 5: Orbiter Right Side Debris Map

TOTAL HITS = 7
HITS > 1 INCH = 0

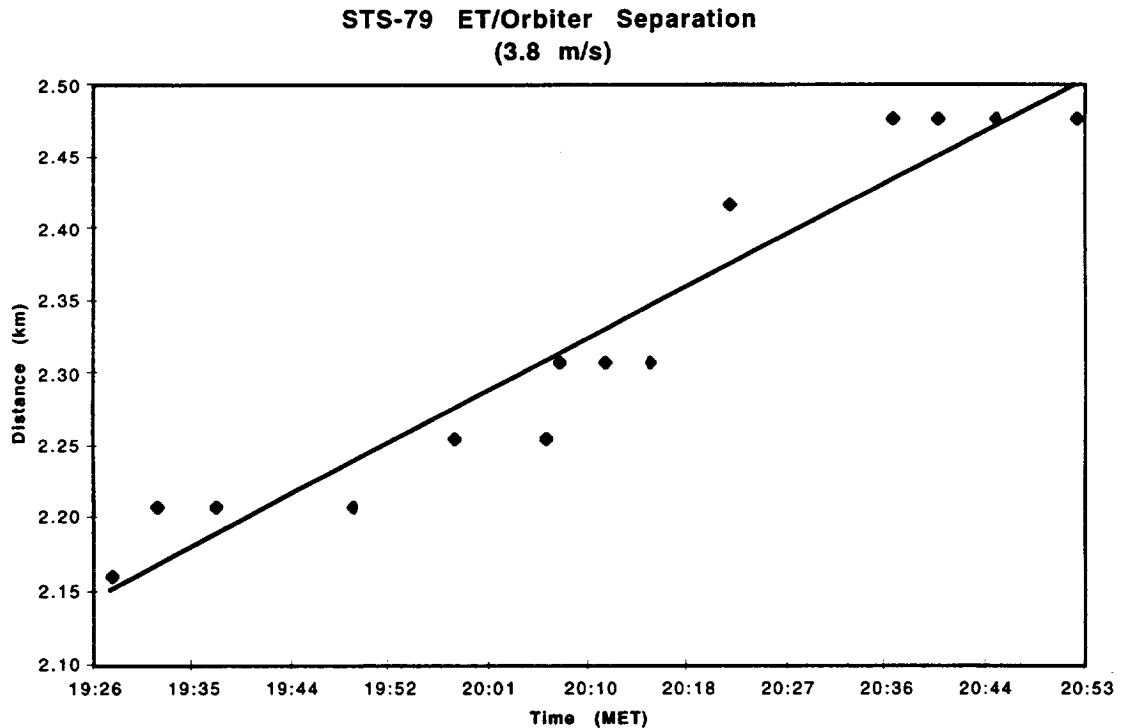
Figure 2.4.2 (B) ET Separation Velocity

The distance of the external tank was calculated over a fourteen-frame sequence using the handheld photography. The external tank was calculated to be a distance of 2.2 km away from the Orbiter at 19:28 MET. The tank was calculated 84 seconds later (20:52 MET) to be at a distance of 2.5 km. The tank separation velocity was determined to be 3.8 m/s. The separation velocity was similar to previous mission measurements. The tank tumble rate was determined to be 1.1 deg/sec. The roll rate of the ET was too small to measure during the 84 second acquisition period of the handheld photography.

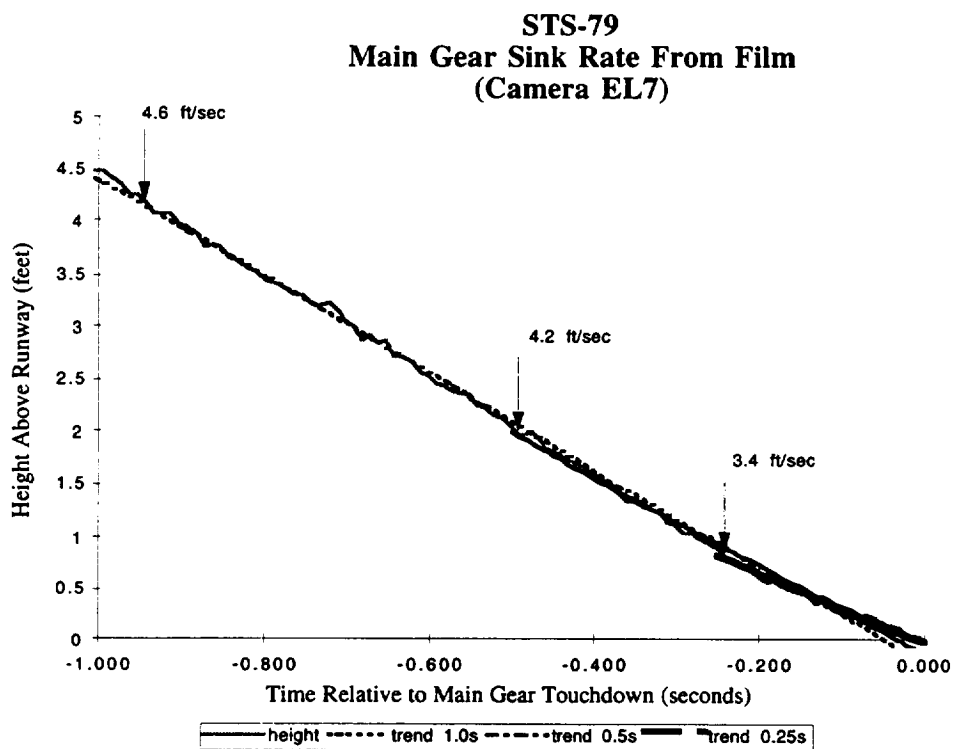
FIGURE 2.6.1(A) MAIN GEAR HEIGHT VERSUS TIME PRIOR TO TOUCHDOWN (FILM)

The measured main gear sink rate values were found to be below the maximum allowable values of 9.6 ft/sec for a 211,000 lb. vehicle and 6.0 ft/sec for a 240,000 lb. vehicle (the landing weight of the STS-79 Orbiter was reported to be 215,000 lb.). The sink rate measurements for STS-79 are given in Table 2.6.1. In Figure 2.6.1(A), and 2.6.1(B), the trend of the measured data points for the film image data is illustrated.
